Macquarie Generation – Project Symphony

## **Liddell Power Station**

### **Preliminary Environmental Site Assessment**

Ref: 0213879RP02\_DRAFT Rev02

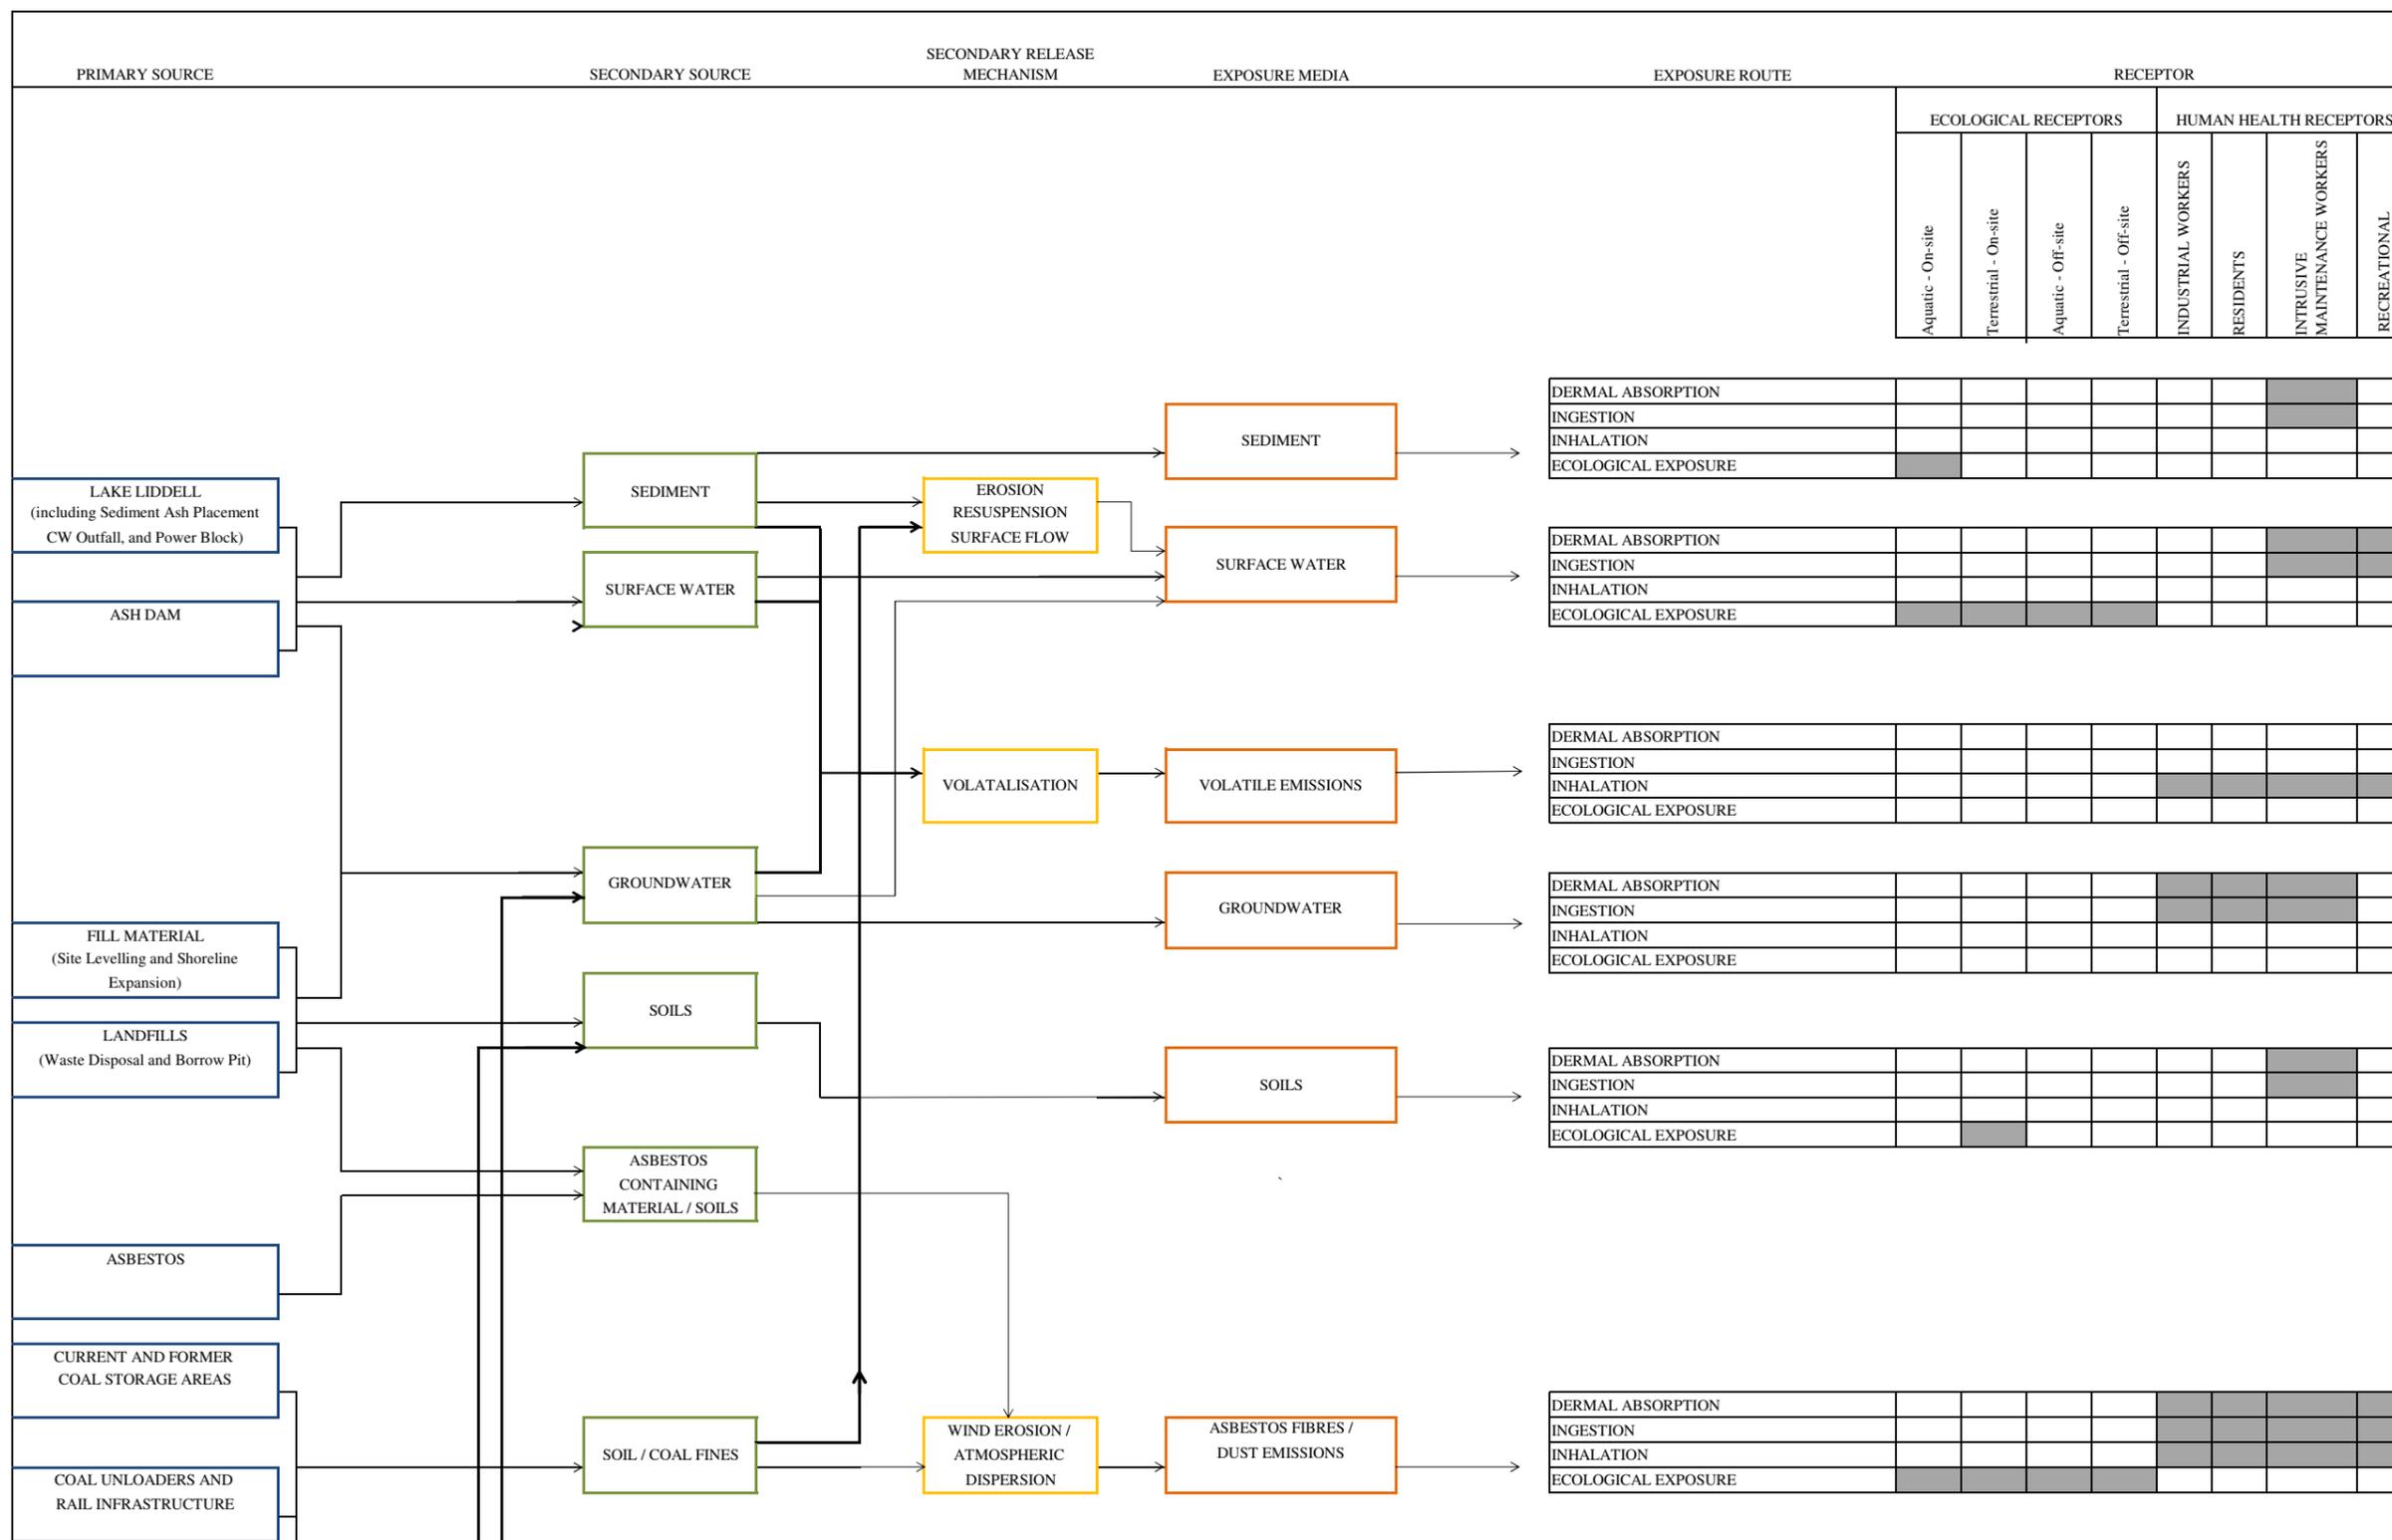
Generalised Conceptual Site Model - Liddell Power Station
