Project Symphony, Liddell Power Station

Stage 2 Environmental Site Assessment

Ref: 0224198RP02

31 January 2014

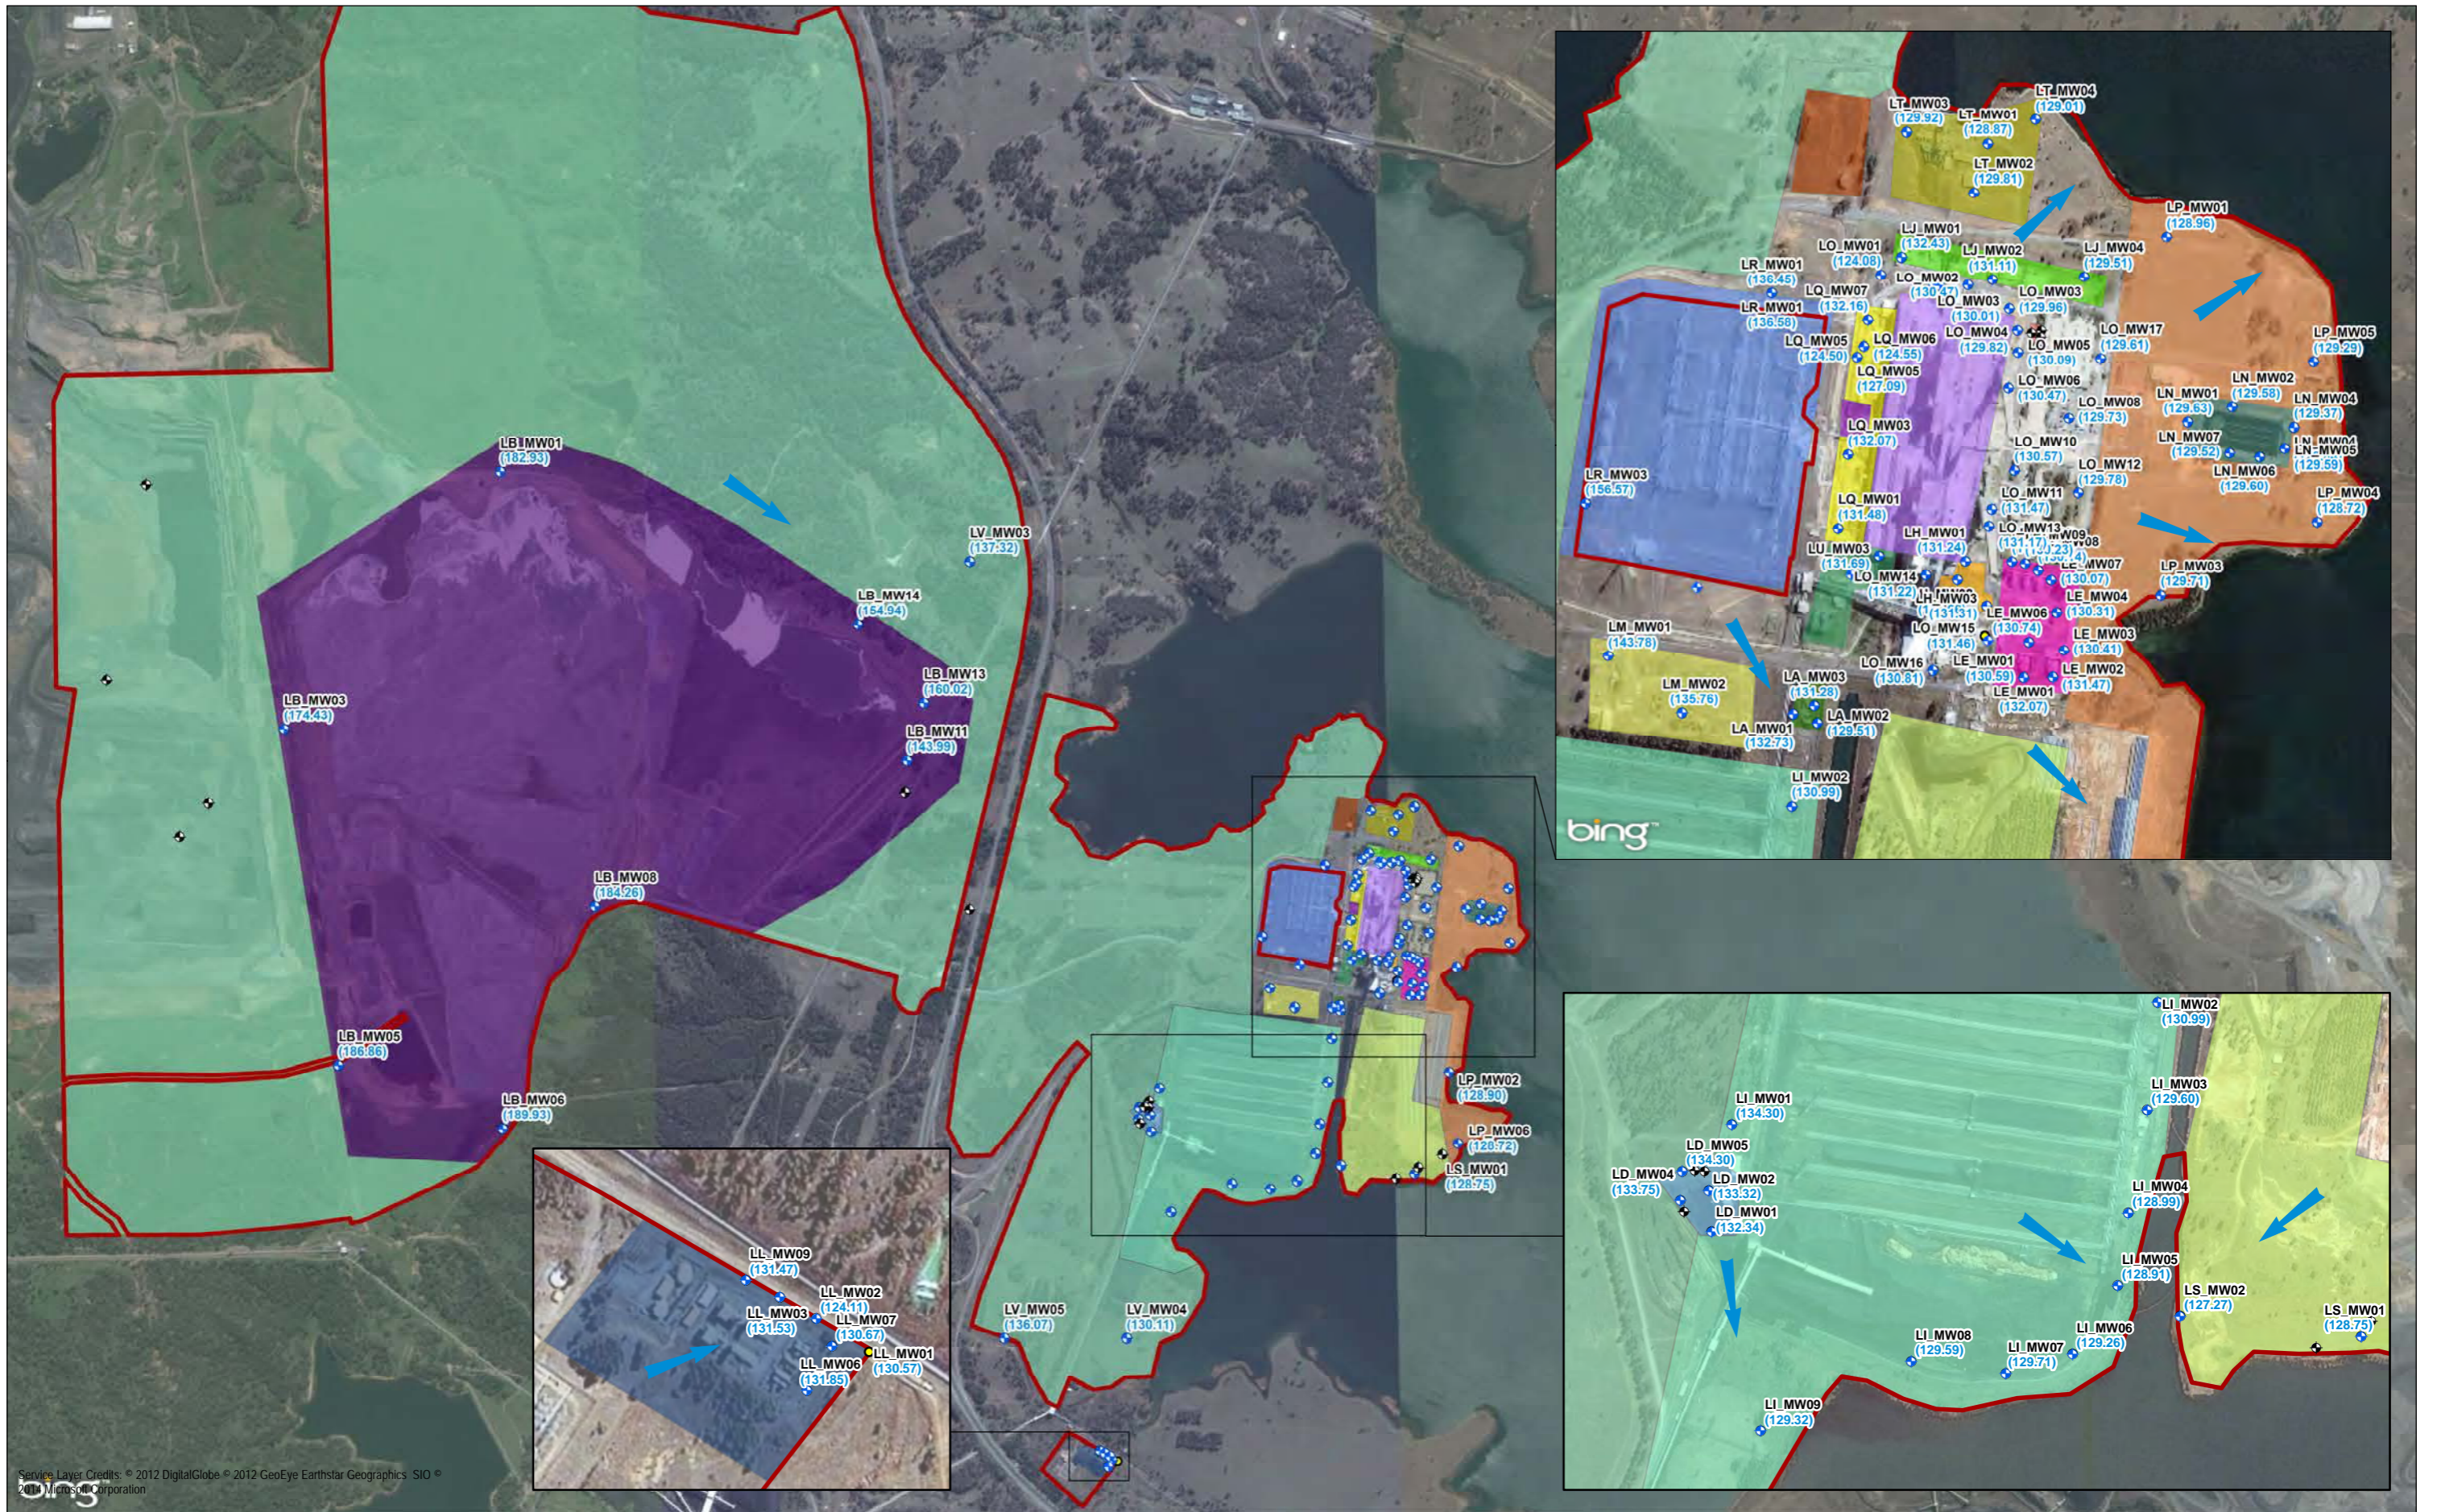
Due to the undulating nature of the topography, variation in localised groundwater flow directions are probable and groundwater flow is expected to follow topography in part with perched infiltrated water expected in some areas. Inferring localised groundwater flow from topography suggests a easterly to north easterly groundwater flow component at the Liddell Power Station towards Lake Liddell.

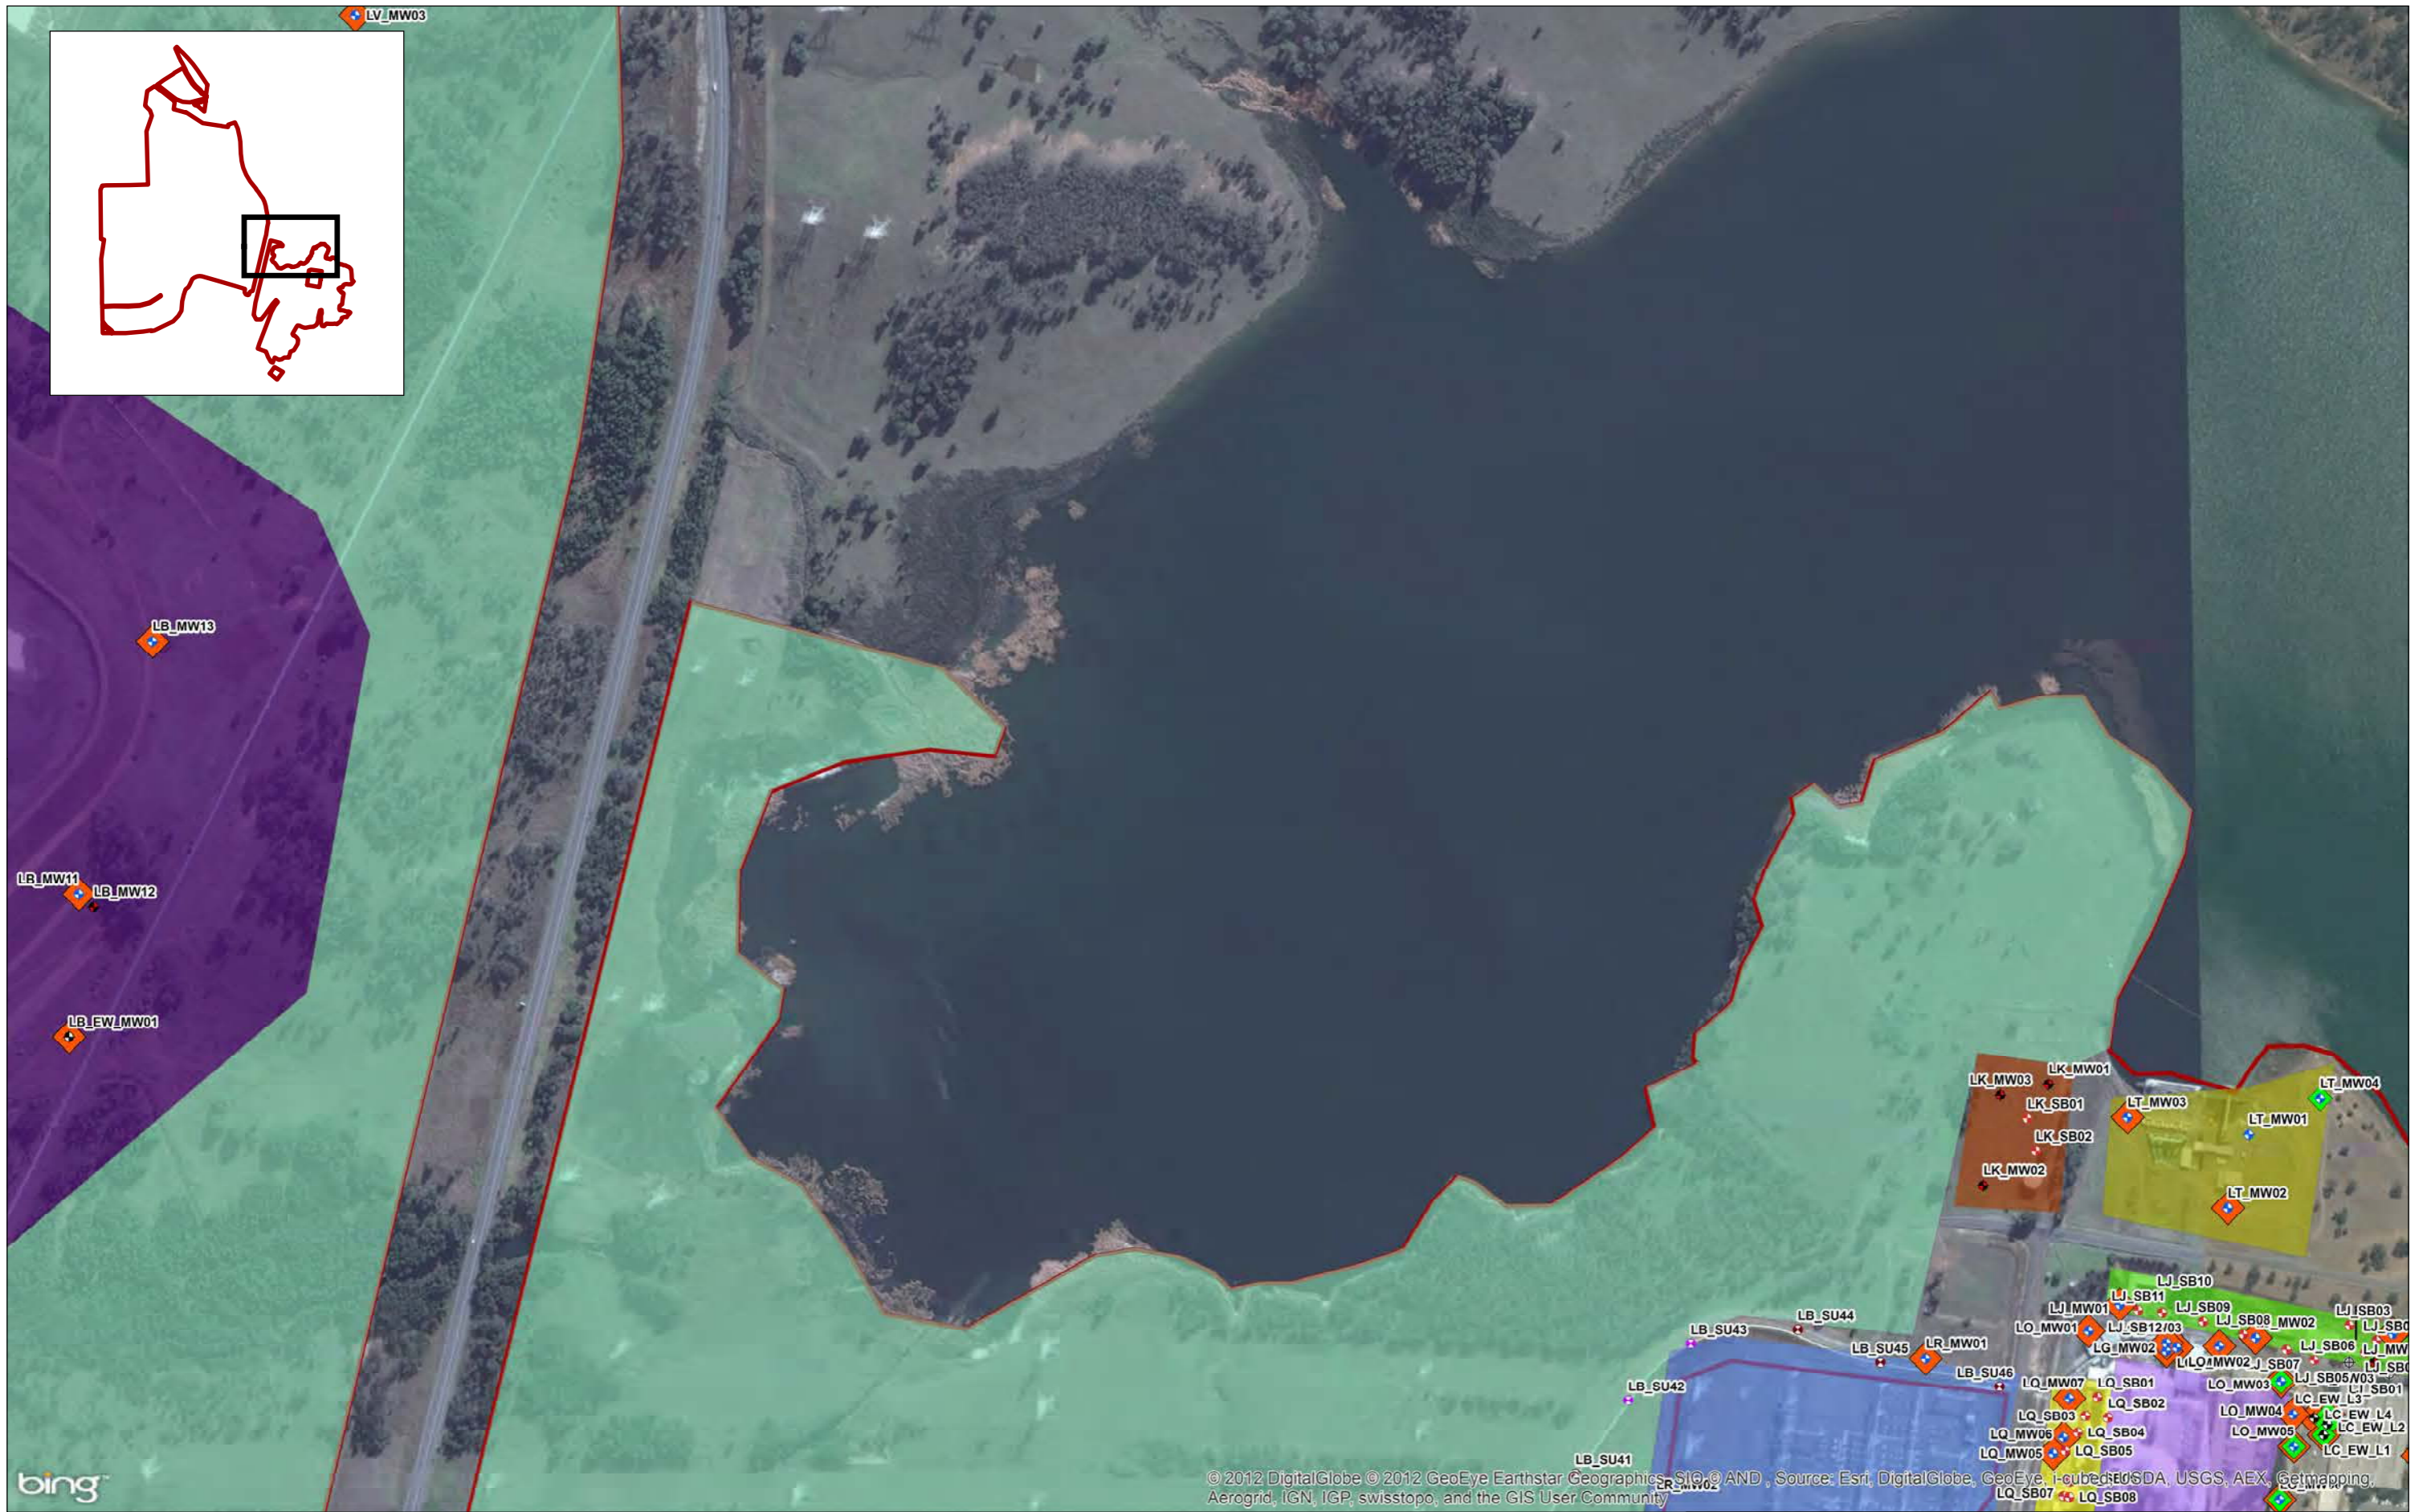
- *Various metals were detected at concentrations above the human health (drinking water) and / or ecological screening values which were not attributable to background conditions in groundwater at a number of locations across the Site. In many instances however, these impacts are related to activities which are already regulated and monitored under the Site EPL. The identified impacts are also generally located well within the site boundaries and up gradient of Lake Liddell, the discharge from which is also monitored and regulated under the Site EPL. ERM considers that NSW EPA would most likely continue to manage this issue under the POEO Act via the Site Environment Protection Licence, and hence would not require formal notification of potential contamination under the CLM Act, however this approach should be confirmed with NSW EPA to ensure strict adherence to the NSW DECC (2009) guidelines.*
